## Euro NCAP Test 2021: Cupra Formentor

## Cupra Formentor

Tested Model	Cupra Formentor 1.5 petrol, LHD
Body Type	- 5 door SUV
Year Of Publication	2021
Kerb Weight	1362kg
VIN From Which Rating Applies	- all Formentors
Class	Small Off-Road

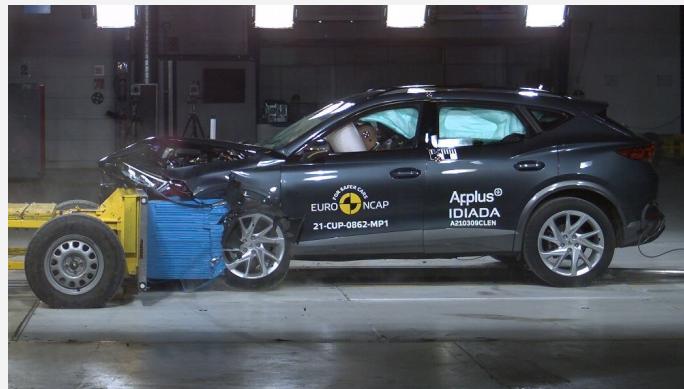
Der Cupra Formentor im frontalen Offsetcrash gegen die rollende Barriere mit Deformationselement (Foto: Euro NCAP)

Die Fahrgastzelle blieb im Offset-Frontal-Test stabil. Der Schutz des Brustkorbs des Fahrers wurde auf der Grundlage von Dummymessungen der Druckbelastung als gering eingestuft. Die Messungen der Belastungen auf Knie und Oberschenkel von Fahrer und Beifahrer ergaben einen guten Schutz. Der Cupra zeigte, dass ein ähnliches Schutzniveau für Insassen sowohl in unterschiedlicher Größe als auch in unterschiedlichen Sitzpositionen gegeben ist.

Die Analyse der rollenden Barriere, gegen die der Formentor prallte, zeigte einige lokale Bereiche mit hoher Verformung, was ein höheres Risiko für das gegnerische Fahrzeug darstellte. Im Test gegen die starre Wand über die gesamte Fahrzeugsbreite war der Schutz für alle kritischen Körperregionen sowohl für den Fahrer als auch für den Beifahrer auf dem Rücksitz gut oder ausreichend. Im Test mit der seitlichen Barriere, der einen Seitenaufprall durch ein anderes Fahrzeug darstellt, war der Schutz für alle kritischen Körperfälle gut. Auch beim schwereren seitlichen Pfahlanprall war der Schutz gut, und der Formentor erreichte die maximale Punktzahl bei den Seitenaufpralltests. Bei der Bewertung des Schutzes beim Seitenaufprall wurde die Auslenkung des Dummies (seine Bewegung auf die andere Seite des Fahrzeugs) als ausreichend bewertet.

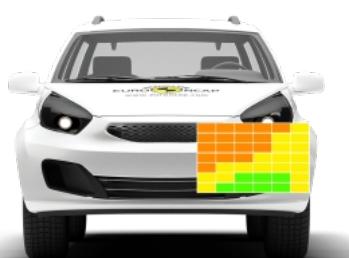
## Frontal Impact

Mobile Progressive Deformable Barrier

Full Width Rigid Barrier

The passenger compartment remained stable in the offset frontal test. Protection of the driver's chest was rated as marginal, based on dummy measurements of compression. Dummy measurements indicated good protection of the knees and femurs of both the driver and passenger. Cupra showed that a similar level of protection would be provided to occupants of different sizes and to those sitting in different positions. Analysis of the barrier into which the Formentor crashed showed some localised areas of high deformation and a modest penalty was applied to the score for the risk this represented to the opposing vehicle. In the full-width, rigid wall test, protection was good or adequate for all critical body regions for both the driver and the rear seat passenger. In the side barrier test, representing a collision by another vehicle, protection of all critical body areas was good for all critical body areas. Similarly, in the more severe side pole impact, protection was good and the Formentor scored maximum points in the full-scale side impact tests. In an assessment of protection in far-side impact, dummy excursion (its movement towards the other side of the vehicle) was rated as adequate. The Formentor is equipped with a centre airbag to protect against occupant-to-occupant interaction in side impacts. This system worked well in Euro NCAP's test, with good protection of the head for both front seat occupants. Tests on the front seats and head restraints demonstrated good protection against whiplash injury in the event of a rear-end collision. A geometric assessment of the rear seats also indicated good whiplash protection. The car is equipped as standard with a multi-collision braking system, which applies the brakes immediately after an impact to prevent the vehicle from being involved in secondary impacts. The Formentor also has an advanced e-Call system which, in the event of an accident, automatically sends a message to the emergency services, giving the car's location.

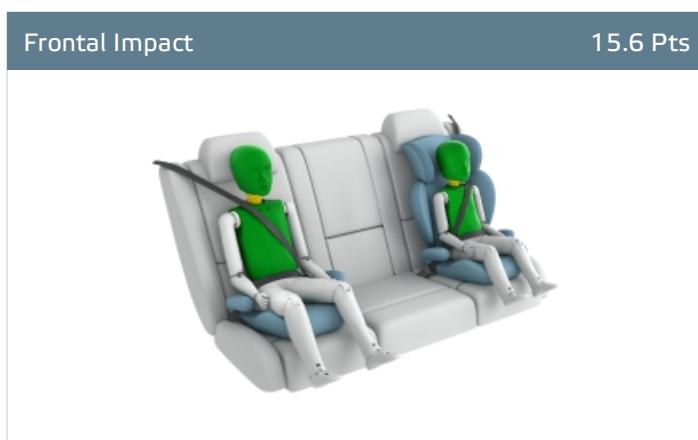
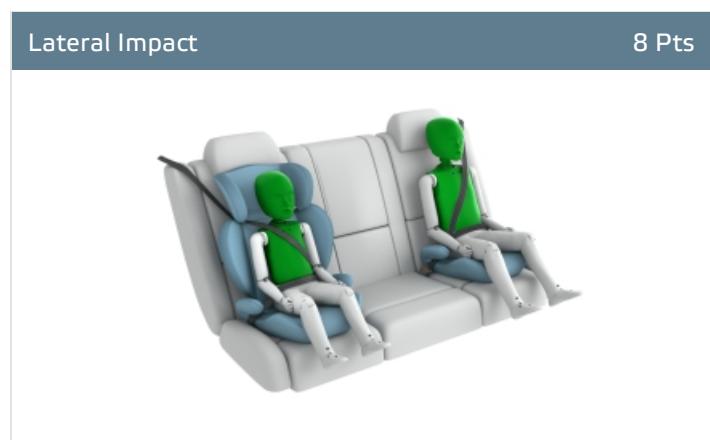
Crash Test Performance based on 6 &amp; 10 year old children

Restraint for 6 year old child: *Britax Römer Kidfix 2S*Restraint for 10 year old child: *Takata Maxi Booster*

In the frontal offset test, protection of both child dummies was good except for that of their necks, protection of which was adequate. In the side barrier test, protection of all critical body regions was good and the Formentor scored maximum points for this part of the assessment. The front passenger airbag can be disabled to allow a rearward-facing child restraint to be used in that seating position. Clear information is provided to the driver regarding the status of the airbag and the system was rewarded. All of the restraints for which the Formentor is designed could be properly installed and accommodated.
