## Euro NCAP Test 2021: **Dacia Sandero**

### Zwei Sterne für den Dacia Sandero

## Dacia Sandero Stepway

Standard Safety Equipment

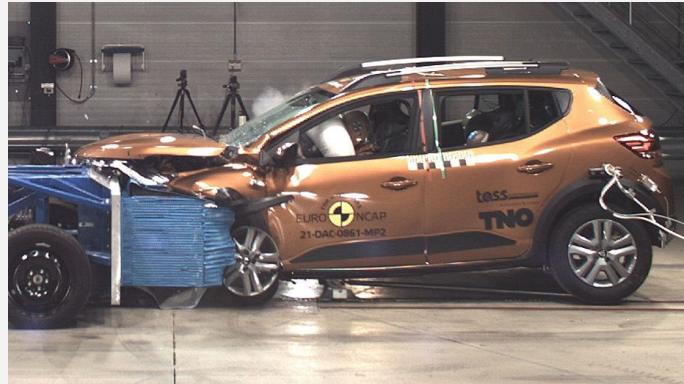
Der Dacia Sandero im frontalen Offsetcrash gegen die rollende Barriere mit Deformationselement (Foto: Euro NCAP)

Die Fahrgastzelle des Sandero Stepway blieb im Frontaloffsetcrashtest stabil. Die Dummymesswerte zeigten einen zumindest ausreichenden Schutz für die Knie und Oberschenkel von Fahrer und Beifahrer. Die Strukturen des Armaturenbretts stellten jedoch ein erhöhtes Verletzungsrisiko für Insassen unterschiedlicher Größe und Sitzpositionen dar, so dass der Schutz für diesen Körperbereich auf „gering“ herabgestuft wurde. Auch der Brustschutz wurde für beide Insassen auf den Vordersitzen als gering eingestuft, basierend auf den Dummy-Messungen der Brustkompression. Der Sandero Stepway ist recht klein und leicht, und die Analyse der verformbaren Barriere nach dem Test ergab, dass er ein gutartiger Crashgegner sein würde. Im Test mit der starren Barriere über die gesamte Breite war der Schutz des Fahrers auf dem Vordersitz und des kleineren Beifahrers auf dem Rücksitz für alle kritischen Körperteile mindestens ausreichend. Im seitlichen Barrieretest zeigte die Brustkompression ein geringes Schutzniveau. Im seitlichen Pfahlanprall wurde der Schutz für alle kritischen Körperbereiche als gut oder ausreichend bewertet. Eine Bewertung der Auslenkung der Insassen zueinander bei einem Seitenaufprall ergab einen schlechten Schutz, und der Sandero Stepway verfügt nicht über eine Schutzmaßnahme, wie z. B. einen Mittelairbag, für diesen Unfalltyp. Tests an den Vordersitzen und Kopfstützen zeigten einen guten Schutz gegen Schleudertrauma bei einem Heckaufprall. Eine geometrische Analyse der Rücksitze ergab jedoch einen geringen Schleudertrauma-Schutz.

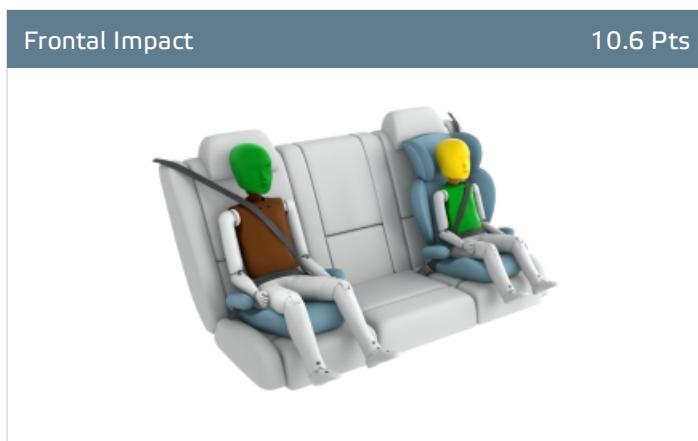
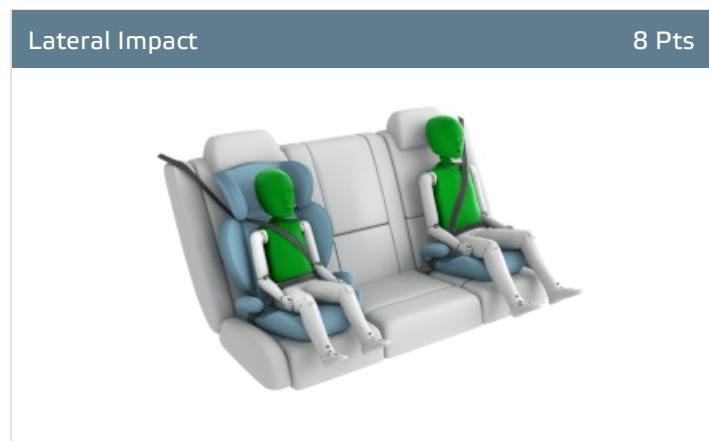
Crash Test Performance based on 6 &amp; 10 year old children

Restraint for 6 year old child: *Britax Römer KidFix XP*Restraint for 10 year old child: *Britax Römer KidFix XP (Booster only)***Safety Features**

In the frontal offset test, protection of the chest and neck of the 10 year dummy was rated as weak, based on dummy readings during the impact. For the 6 year dummy, protection of the neck was marginal while that of the head and chest was adequate and good respectively. The front passenger airbag can be disabled to allow a rearward-facing child restraint to be used in that seating position. Clear information is provided to the driver regarding the status of the airbag and the system was rewarded. All of the child restraints for which the Sandero Stepway is designed could be properly installed and accommodated. One, a full sized rearward facing toddler restraint, could be fitted in the car with no problem but was deemed a fail because Dacia indicate in the user manual that the car cannot accommodate this (R3) category of restraint.

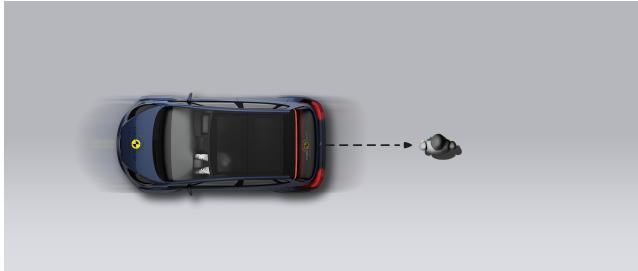
Vehicle reversing into standing pedestrian

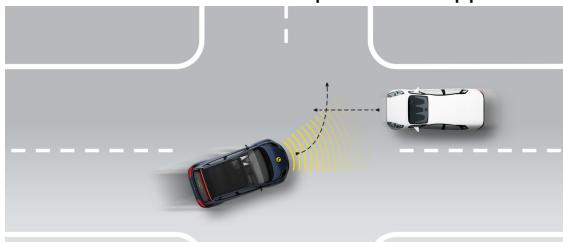
Test car turns across the path of an approaching car

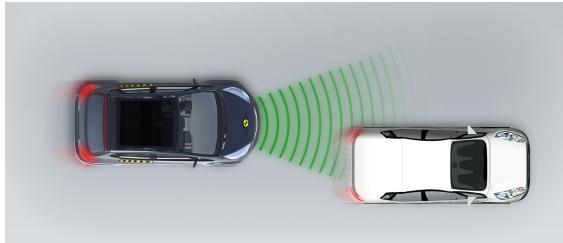
Approaching a slower moving car

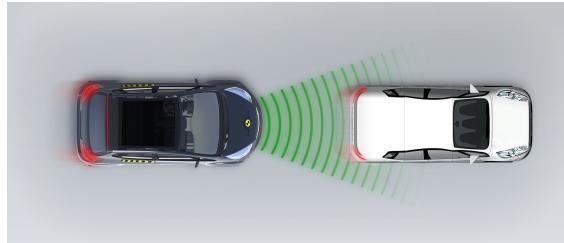
Approaching a slower moving car

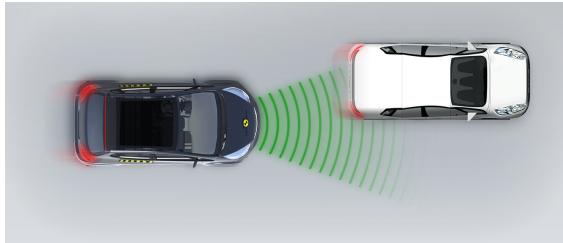
Approaching a slower moving car

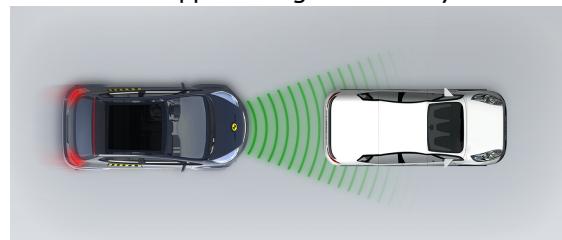
Approaching a stationary car

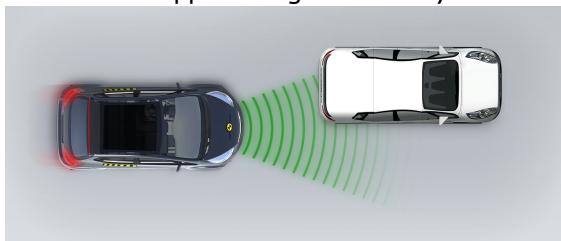
Approaching a stationary car

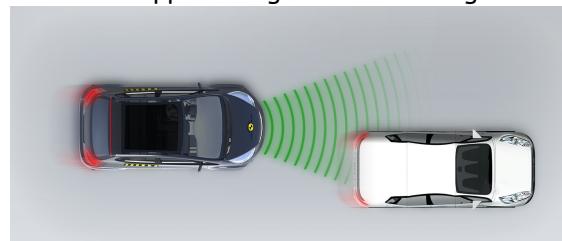
Approaching a slower moving car

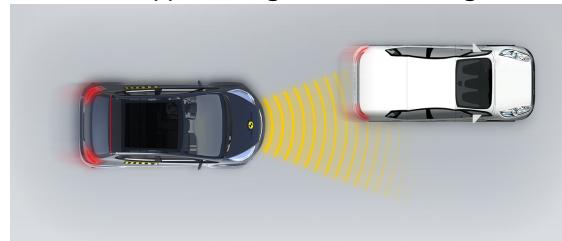
Approaching a slower moving car

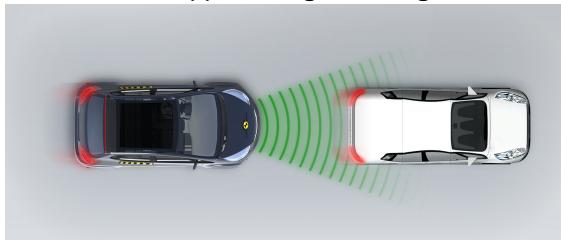
Approaching a braking car
