Euro NCAP Test 2021: Hyundai TUCSON

Fünf Sterne für den Hyundai TUCSON

Hyundai TUCSON
Standard Safety Equipment

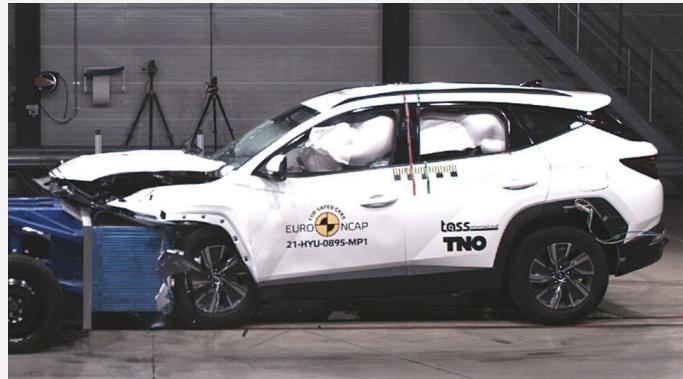
Der Hyundai TUCSON im frontalen Offsetcrash gegen die rollende Barriere mit Deformationselement (Foto: Euro NCAP)

Die Fahrgastzelle des TUCSON blieb beim versetzten Frontalcrashtest stabil. Die Dummy-Werte zeigten einen guten Schutz der Knie und Oberschenkel von Fahrer und Beifahrer. Hyundai wies nach, dass den Beinen von Insassen unterschiedlicher Größe und in verschiedenen Sitzpositionen ein ähnliches Schutzniveau geboten würde. Der Schutz der Brust des Fahrers war gering. Die Analyse der Verzögerung des entgegenrollenden Barrierewagens während des Tests und die Analyse der verformbaren Barriere nach dem Test ergaben, dass der TUCSON bei einem Frontalaufprall ein mäßig guter Aufprallpartner wäre. Im Test gegen die starre Barriere über die gesamte Fahrzeugsbreite wurde für die meisten kritischen Körperbereiche ein guter oder ausreichender Schutz gewährleistet. Der Schutz des Brustkorbs des Fahrers wurde jedoch, basierend auf den Druckwerten des Dummies, als gering eingestuft.

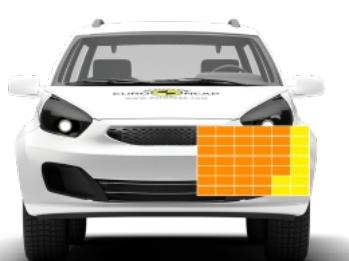
Frontal Impact

Mobile Progressive Deformable Barrier

Full Width Rigid Barrier

The passenger compartment of the TUCSON remained stable in the frontal offset test. Dummy numbers showed good protection of the knees and femurs of both the driver and passenger. Hyundai showed that a similar level of protection would be provided to the legs of occupants of different sizes and to those sitting in different positions. Protection of the driver's chest was marginal. Analysis of the deceleration of the impact trolley during the test, and analysis of the deformable barrier after the test, revealed that the TUCSON would be a moderately benign impact partner in a frontal collision. In the full-width rigid barrier test, good or adequate protection was provided to most critical body areas. However, driver chest protection was rated as marginal, based on dummy readings of compression. In the side barrier test, protection of all critical body areas was good or adequate. In the more severe side pole impact, protection of all critical body areas was good and the car scored maximum points for this part of the assessment. The TUCSON has a centre airbag to mitigate occupant to occupant injuries in the event of a lateral collision. In Euro NCAP's test, the airbag worked well, with good protection of the dummies' heads. Limitation of the extent to which a body is thrown to the other side of the car in a side impact was rated as adequate. Tests on the front seats and head restraints demonstrated good protection against whiplash injuries in the event of a rear-end collision. A geometric analysis of the rear seats also indicated marginal whiplash protection. The TUCSON has, as standard, an advanced emergency call system which alerts the emergency services in the event of a crash. The car also applies the brakes after a collision to prevent secondary impacts.

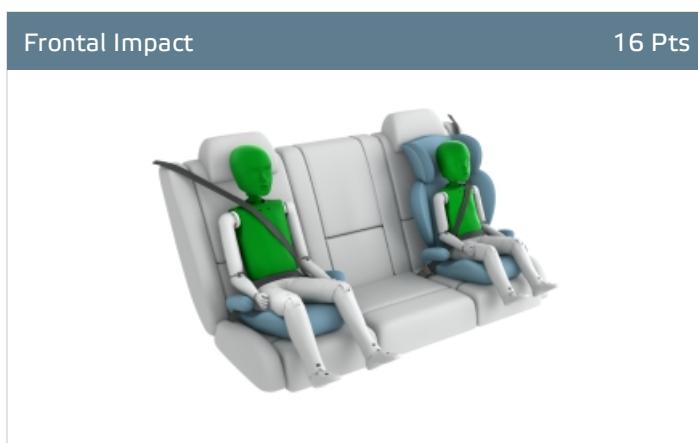
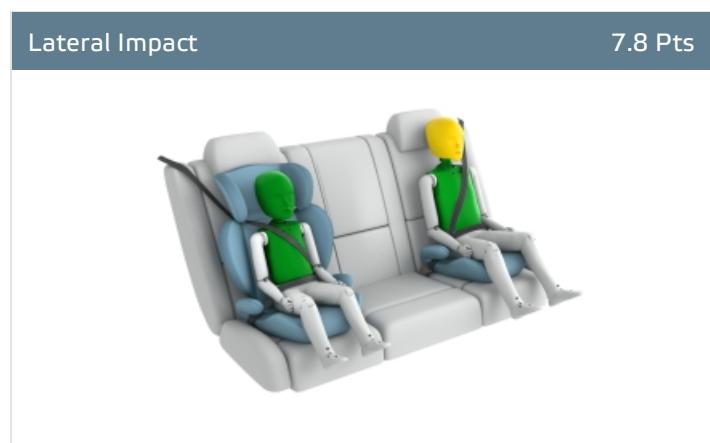
Crash Test Performance based on 6 & 10 year old children

Restraint for 6 year old child: *Britax Römer KidFix2 R*Restraint for 10 year old child: *Graco booster***Safety Features**

In the both the frontal offset test and the side barrier impact, protection of all critical body areas was good or adequate for both child dummies. The front passenger airbag can be disabled to allow a rearward-facing child restraint to be used in that seating position. Clear information is provided to the driver regarding the status of the airbag and the system was rewarded. All of the child restraint types for which the TUCSON is designed could be properly installed and accommodated in the car.

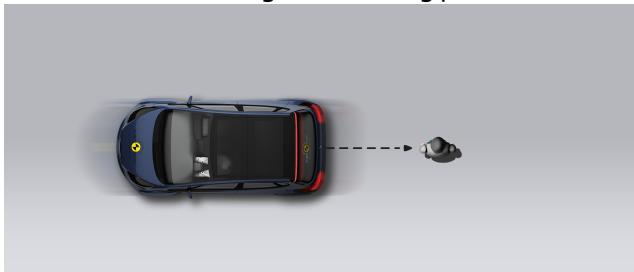
Vehicle reversing into standing pedestrian

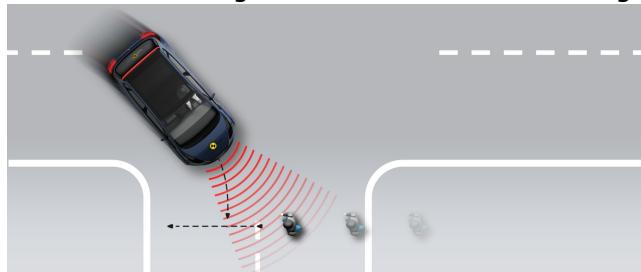
Pedestrian crossing a road into which a car is turning

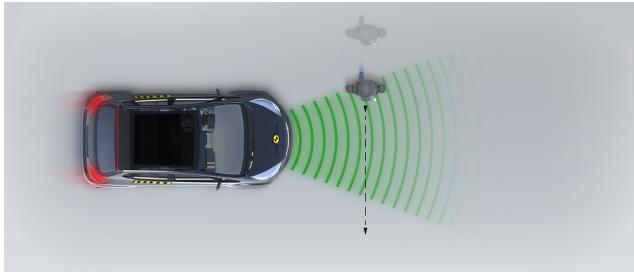
Adult crossing the road

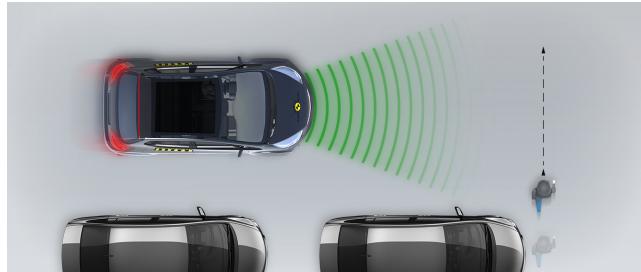
Child running from behind parked vehicles

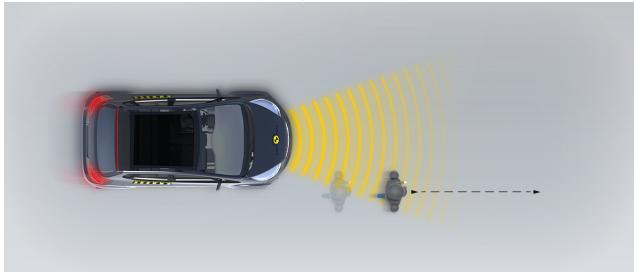
Adult along the roadside

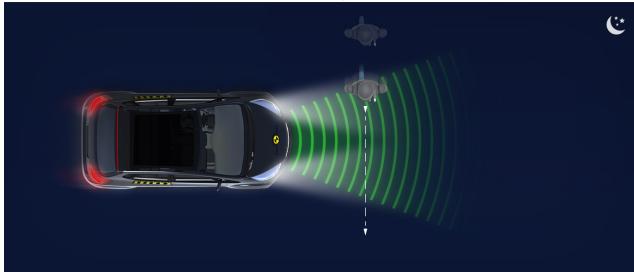
Adult crossing the road

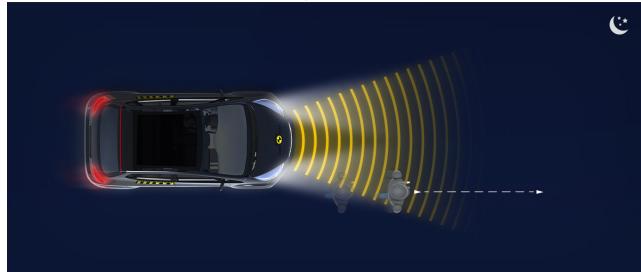
Adult along the roadside

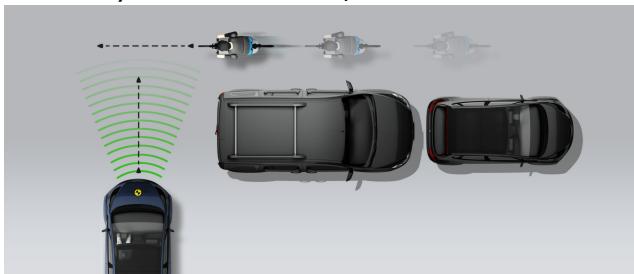
Cyclist from nearside, obstructed view

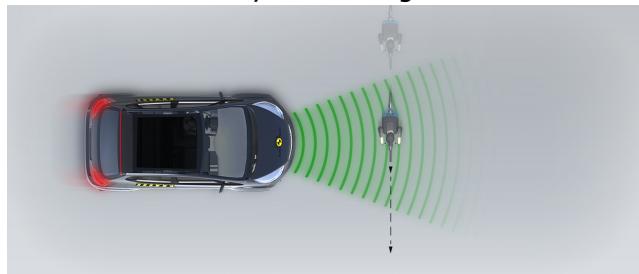
Cyclist crossing

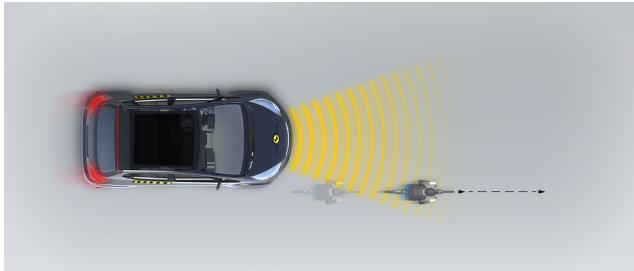
Cyclist along the roadside

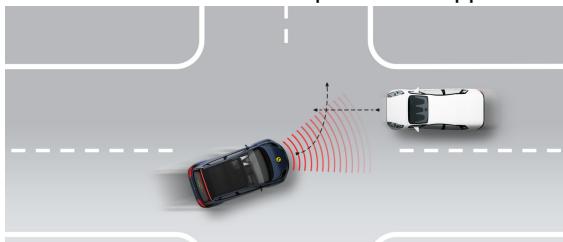
Test car turns across the path of an approaching car

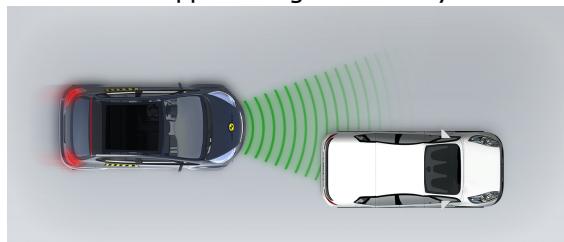
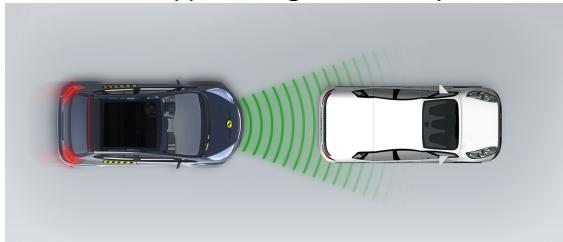
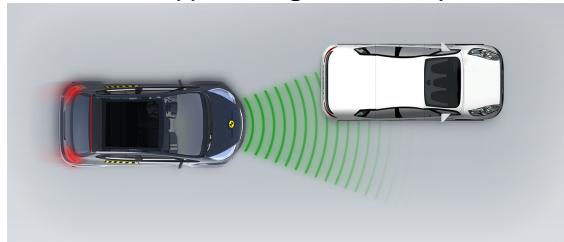
Approaching a stationary car

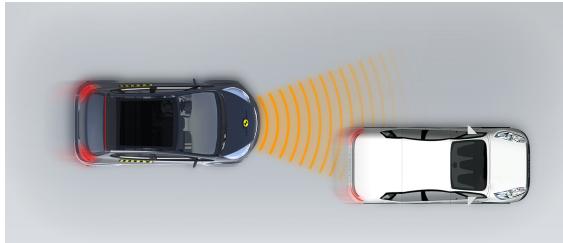
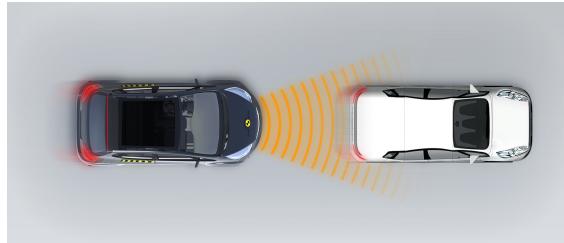
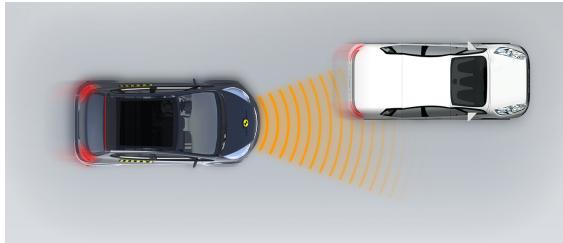
Approaching a slower moving car

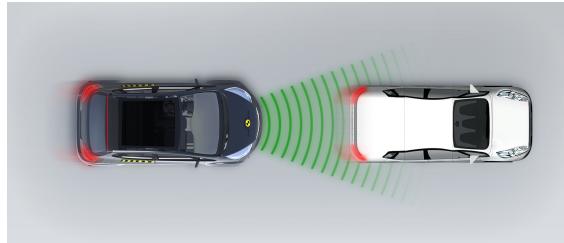
Approaching a braking car

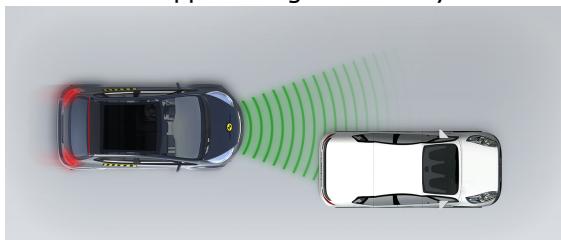
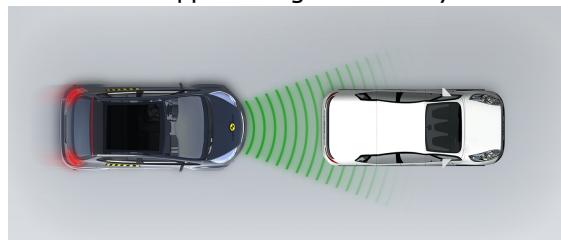
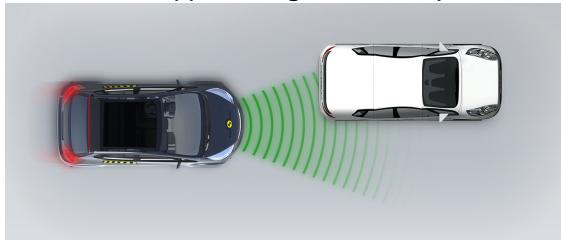
Approaching a stationary car

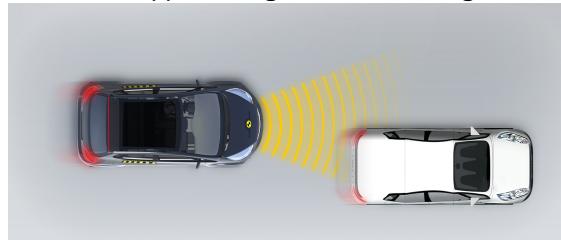
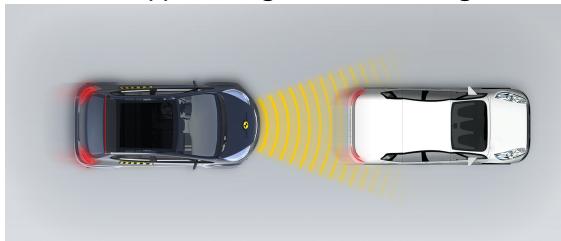
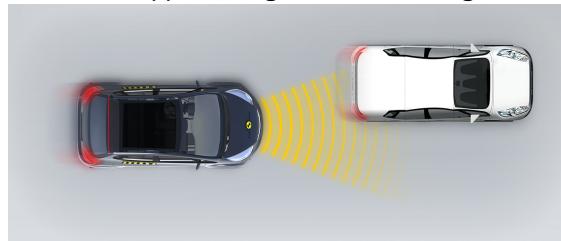
Approaching a slower moving car

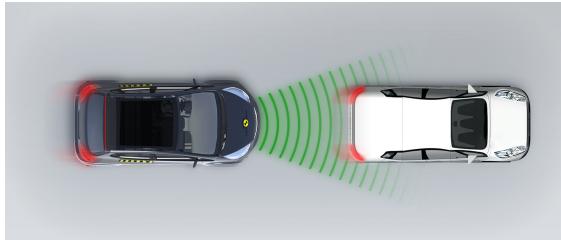
Approaching a braking car
