# Euro NCAP Test 2023:
# Kia EV9

## Fünf Sterne für den Kia EV9

# Kia EV9

2023

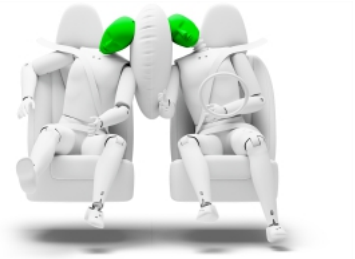
Beim Seitencrashtest war der Schutz aller kritischen Körperbereiche gut, der EV9 erreichte in diesem Teil der Bewertung die maximale Punktzahl. Bei dem schwereren seitlichen Pfahlanprall zeigten die Dummymesswerte für die Rippenkompression einen geringen Schutz des Brustkorbs an. Die Kontrolle der Auslenkung (das Maß, in dem ein Körper auf die andere Seite des Fahrzeugs geschleudert wird) war ausreichend. Der EV9 verfügt über eine Gegenmaßnahme (Zentralairbagsystem), die bei einem solchen Aufprall Verletzungen der vorderen Insassen untereinander verhindert, diese hat im Euro NCAP-Test gut abgeschnitten.

### Lateral Impact — 15.3 / 16 Pts
