Euro NCAP Test 2021: Renault Zoe

Null Sterne für den Renault Zoe

Renault Zoe
Standard Safety Equipment

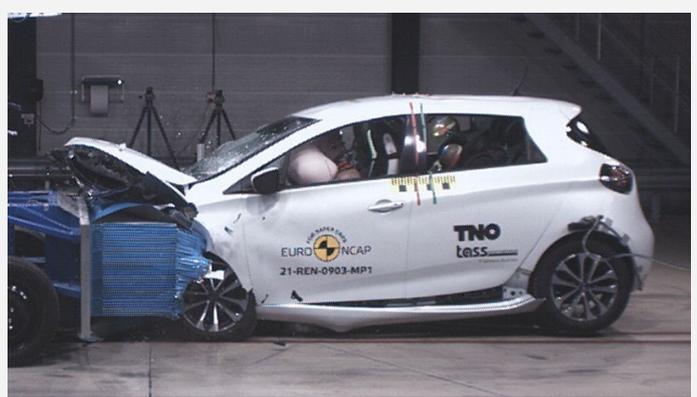
Der Renault Zoe im frontalen Offsetcrash gegen die rollende Barriere mit Deformationselement (Foto: Euro NCAP)

Die Fahrgastzelle des Zoe blieb beim versetzten Frontalaufpralltest stabil. Die Messwerte für die linke Kniescheibe des Beifahrer-Dummys waren im Vergleich zu den empfohlenen Grenzwerten hoch. In Verbindung mit dem Abzug für Strukturen im Armaturenbrett, die für Insassen unterschiedlicher Größe eine Gefahr darstellen könnten, führte dies dazu, dass der Schutz dieses Bereichs als ungenügend bewertet wurde. Der Schutz des Brustkorbs des Fahrers wurde auf Grundlage der vom Dummy während des Tests gemessenen Brustkorbkompression als schwach eingestuft. Die Analyse der Verzögerung des entgegenkommenden Barrierewagens während des Tests und der Verformung der Barriere danach ergab, dass der Zoe ein mäßig aggressiver Crashpartner für andere Fahrzeuge sein würde. Im Test gegen die starre Barriere über die gesamte Fahrzeugbreite wurde das Ergebnis für das Maß der Vorwärtsbewegung des Kopfes des hinteren Beifahrers abgewertet, und der Schutz wurde als gering eingestuft. Der Schutz des Brustkorbs des hinteren Dummys wurde auf Grundlage von Kompressionsmessungen ebenfalls als gering eingestuft.

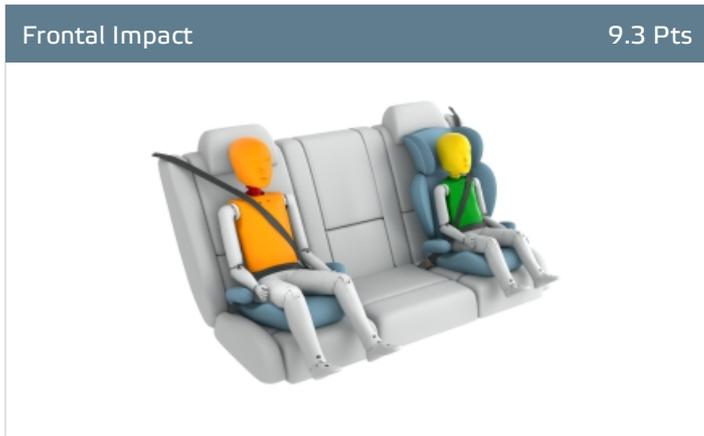
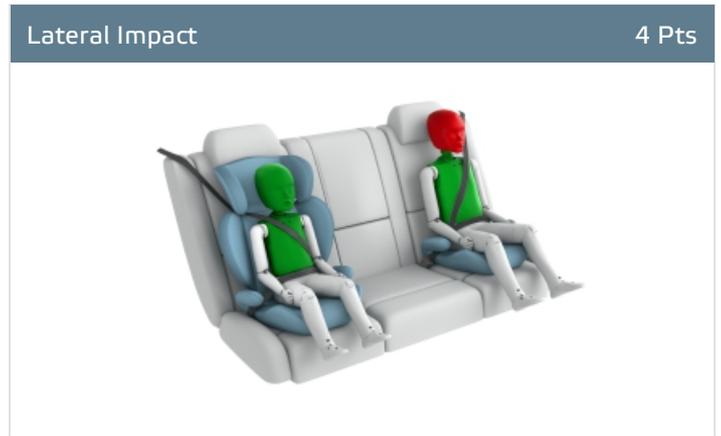
Crash Test Performance based on 6 & 10 year old children

Restraint for 6 year old child: *Britax Römer KidFix XP*
 Restraint for 10 year old child: *Britax Römer KidFix XP - booster only*

In the frontal offset test, tensile forces in the neck of the 10 year dummy indicated poor protection of this part of the body. The head and chest of the same dummy were marginally protected. In the side barrier impact, the head of the 10 year old dummy contacted the vehicle interior and protection was rated as poor. The front passenger airbag can be switched off to allow a rearward facing child restraint to be used in that seating position. The installation check on the Group II/III ISOFIX child restraint was deemed a fail owing to conflicting information between the CRS manufacturer and Renault.
